Wear and Ion Erosion in Spinning Disk Fences made with Al and Torlon

Abstract: Wear effects are evaluated in spinning wheel wafer fixture components made from Al and Torlon materials exposed to high current ion beam exposures and over 350,000 wafer moves over extended time periods. Metrologies used include: (1) optical and SEM microscopy (surface texture changes), (2) optical profilometry (wafer wear and ion erosion), (3) RBS (chemical composition and accumulated ion dose), (4) TOF-SIMS and ICPMS (elemental contamination on wafers). In addition, we present in-line data on reduced wafer chipping with Torlon replacing Al fences.

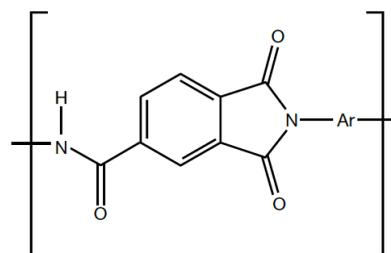
Figure 1. Structure of Torlon polyamide-imide polymer.

High-strength polymer Torlon is widely used in high performance parts where wear resistance and mechanical strength are required [2]. Torlon is available in a variety of formulations based on a polyamide-imide core molecule (Fig. 1) with general high performance from cryogenic temperatures to above ≈ 260 C. Torlon parts are especially notable for high tensile strength, lubricity (low coefficient of friction) and wear resistance to metals and other hard materials abrasion.

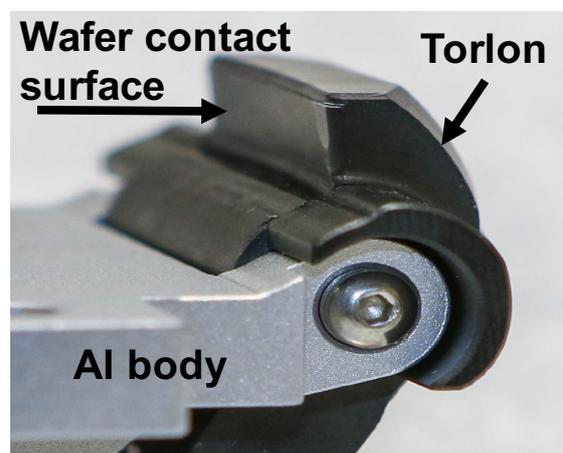
Figure 2. Photo a Torlon fence assembly for a 200 mm GSD disk.

A practical design for the use of high-strength polymer Torlon wafer fences is shown in Fig. 2 for use in GSD-type spinning wheels. The Torlon part replaces an Al alloy component. Corresponding fixtures for fixed restraints in AMAT-9500-type spinning wheels are shown in Fig. 3.

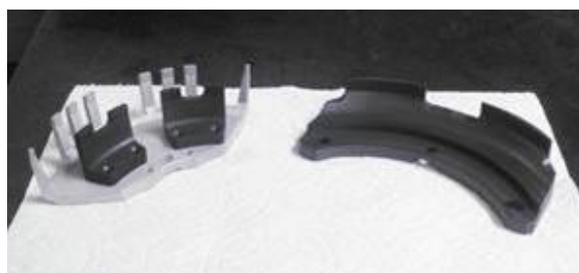
Figure 3. Photo of fixed restraints for AMAT-9500-type 150 (left) and 200 (right) mm spinning wheels.

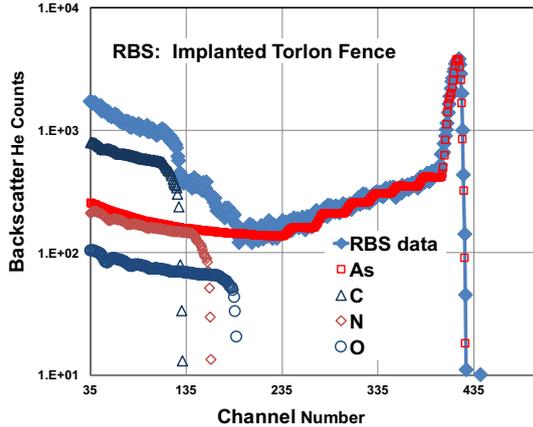
Figure 4. RBS spectra from the top exposed surface of a heavily implanted Torlon fence part showing a strong As accumulated dose on the surface. Also shown are the C, N and O material components fitted to the total RBS signal.

The RBS measurements were done with 2.275 MeV He²⁺ beams backscattered to a detector at 160° relative to the incident beam. The assumed Torlon density was 1.15e23 atoms/cm³. The Torlon and implanted As compositions were fitted to the observed backscatter spectrum.

RBS measurements (Fig. 4) from the top surface of heavily implanted Torlon fence part confirmed the high dose As exposure.

These results show that the C, O, & N concentrations exhibit only slight variations in depth under the high-dose As profile. This suggests that the Torlon did not outgas or otherwise change its overall chemical properties.

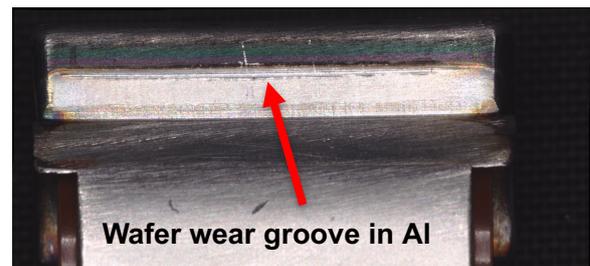
Laser illuminated optical imaging (Fig. 5) of an Al fence part after over a year in service shows considerable grooving at the wafer edge contact as well as photoresist residue build up above the wafer plane.

Figure 5. Optical image (VR view) of wafer edge wear in Al fence with $>350,000$ wafer moves per disk.

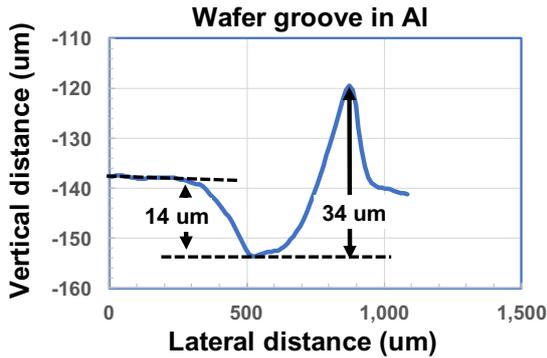
A scanning optical VK profile (Fig. 6) of the Al fence shows a 14 μ m deep groove and a 34 μ m high extrusion ridge in the area of the wafer contact. The profile is indicative of plastic deformation and material erosion. The sharp edge of the groove is thought to be largely responsible for the observed wafer chipping/breakage rates.

Figure 6. VK measurement of a wear depth profile at the wafer contact in a heavily used Al fence, groove depth ~14um.

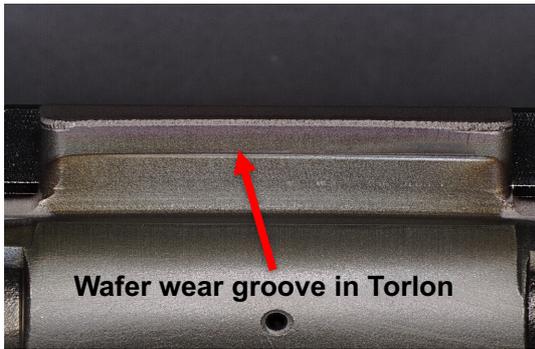
Figure 7. VR optical image of wafer mark on Torlon fence after >350,000 wafer moves on disk. The mark is visually distinct under laser illumination but has very little depth, (see Fig. 7).

Laser optical imaging and depth measurements on Torlon fence parts after over one year in service showed a distinctly visible wafer contact mark (Fig. 7), however the measured groove depth was only 6.6 um (Fig. 8).

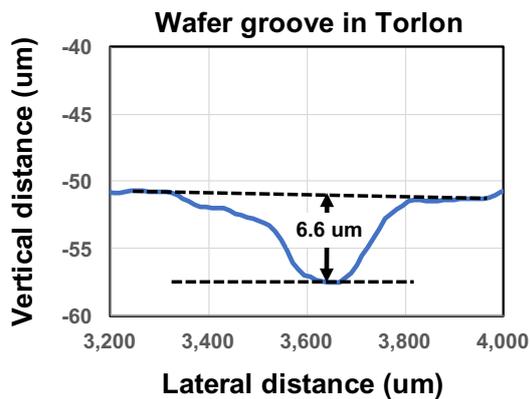
Figure 8. Optical measurement of wear depth profile at the wafer contact in a heavily used Torlon fence, ~6.6um

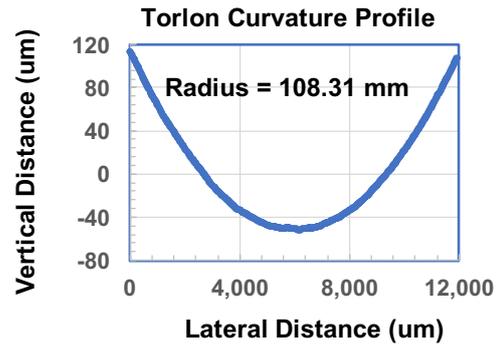
Large area optical scans of Torlon part contours showed no evidence of plastic deformation or radial distortion from the original dimensions and shape (Fig. 9).

Figure 9. VR measurement Torlon fence curvature at the wafer contact plane, showing no distortion from the original shape due to extended ion exposure.
